Amendment 39-17225; AD 2012-21-09]

Airworthiness Directives; Eurocopter France Helicopters

2012-21-09 **EUROCOPTER FRANCE:** Amendment 39-17225; Docket No. FAA-2012-1128; Directorate Identifier 2012-SW-064-AD.

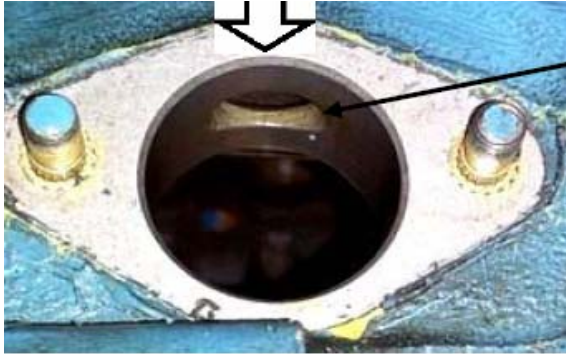
Figure 1 to paragraph (e)(1)(ii)

This AD defines the unsafe condition as a missing through-hole, joining the integrated collector to the magnetic plug. This condition could result in failure of the chip-detector system to detect deterioration of the main rotor mast lift bearing, failure of the lift bearing, and subsequent loss of control of the helicopter.

(ii) Determine if the hole above the magnetic plug is a through-hole as shown in figures 1 and 2 to paragraph (e)(1)(ii) of this AD.

(2) If the hole above the magnetic plug is not a through-hole, before further flight, replace the epicyclic module with an airworthy epicyclic module.
